electrical focus

Energy Safety

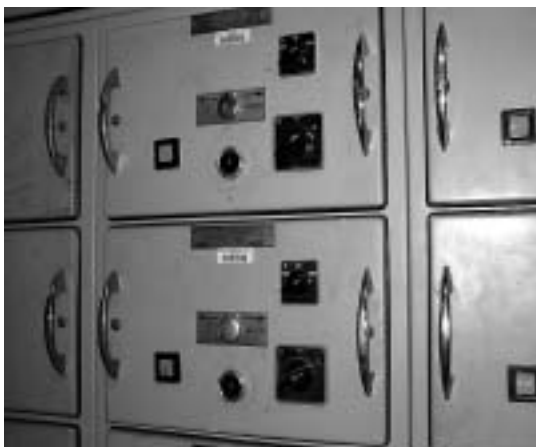
The warning follows an incident where it appears cables within the combined fused switch carriage shorted to earth, causing a severe electrical fault and fire at a major public institution.

The type of switchboard that is subject to this electrical safety warning

electrical installations that contain switchgear as shown below be inspected for damage as soon as practicable to ensure that similar incidents are avoided. Particular attention should be given to:

- Broken and deteriorated tension springs
- Damaged cables within the combined fused switch carriage
- Heat damage to connection points
- Foreign and loose items within the combined fused switch carriage.

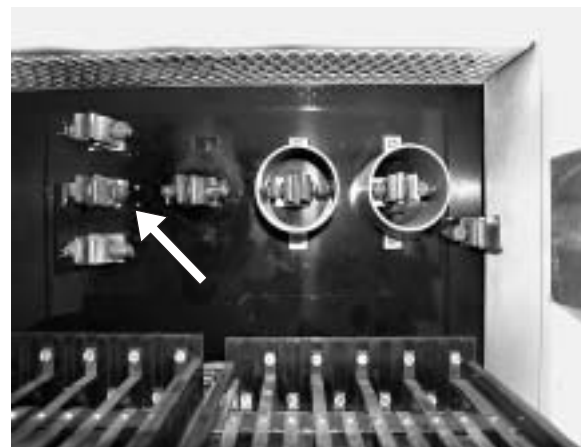
Heat damage causes tension springs to fail
