# **Significant Incident Summary No. 6**

## Offshore platform decommissioning near miss

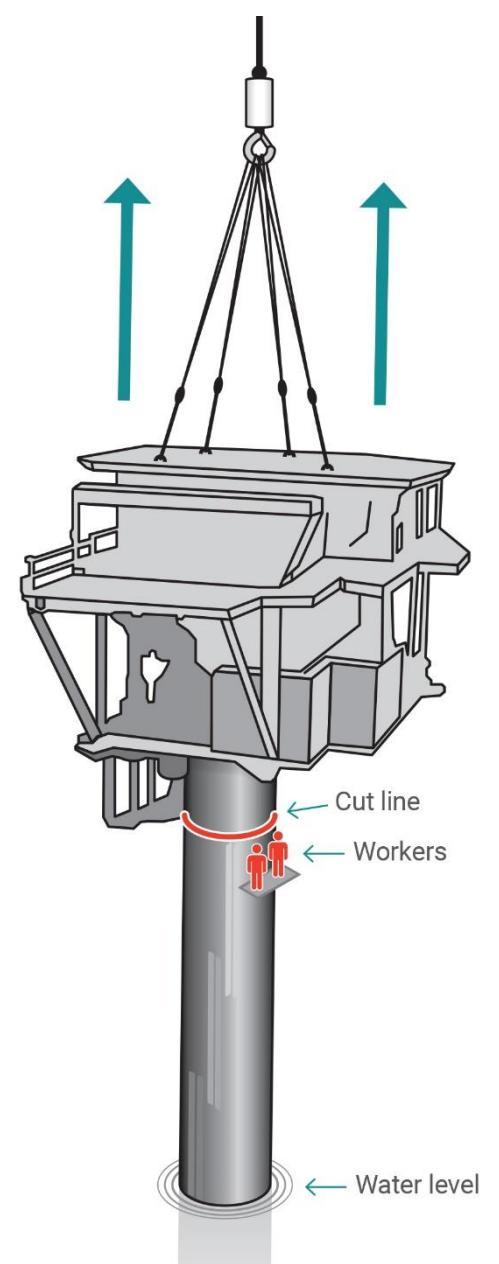
**Figure 1:** Pre-load tension is applied to the load. The force is insufficient to lift load under stationery conditions but is greater than required to lift the rigging.

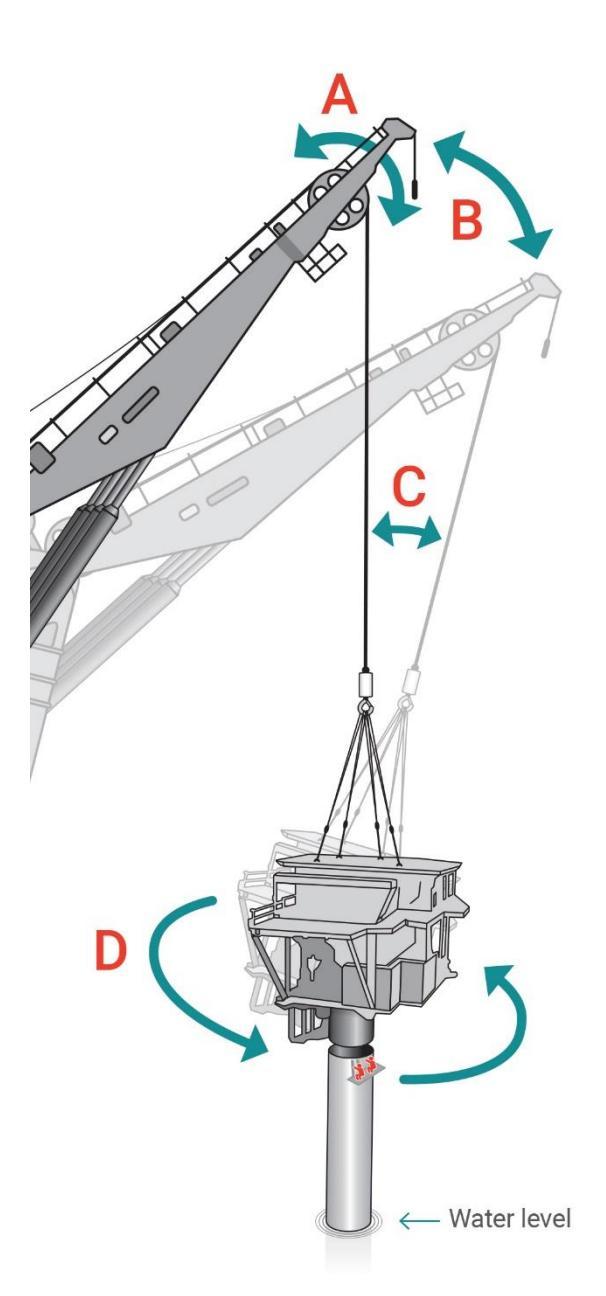
**Figure 2:** Unanticipated forces act on the load during the cutting of the caisson. The crane's autotension mode functions (**A**) in response to these forces and the crane head moves (**B**). The hoist rope shifts out of plumb (**C**) with the load's centre of gravity and the platform begins to lift and rotate (**D**). Alternating forces act on the load and the crane autotension mode compensates by re-adjusting the tension. The crane head returns to its original position and the cycle repeats as the autotension mode adjusts again.

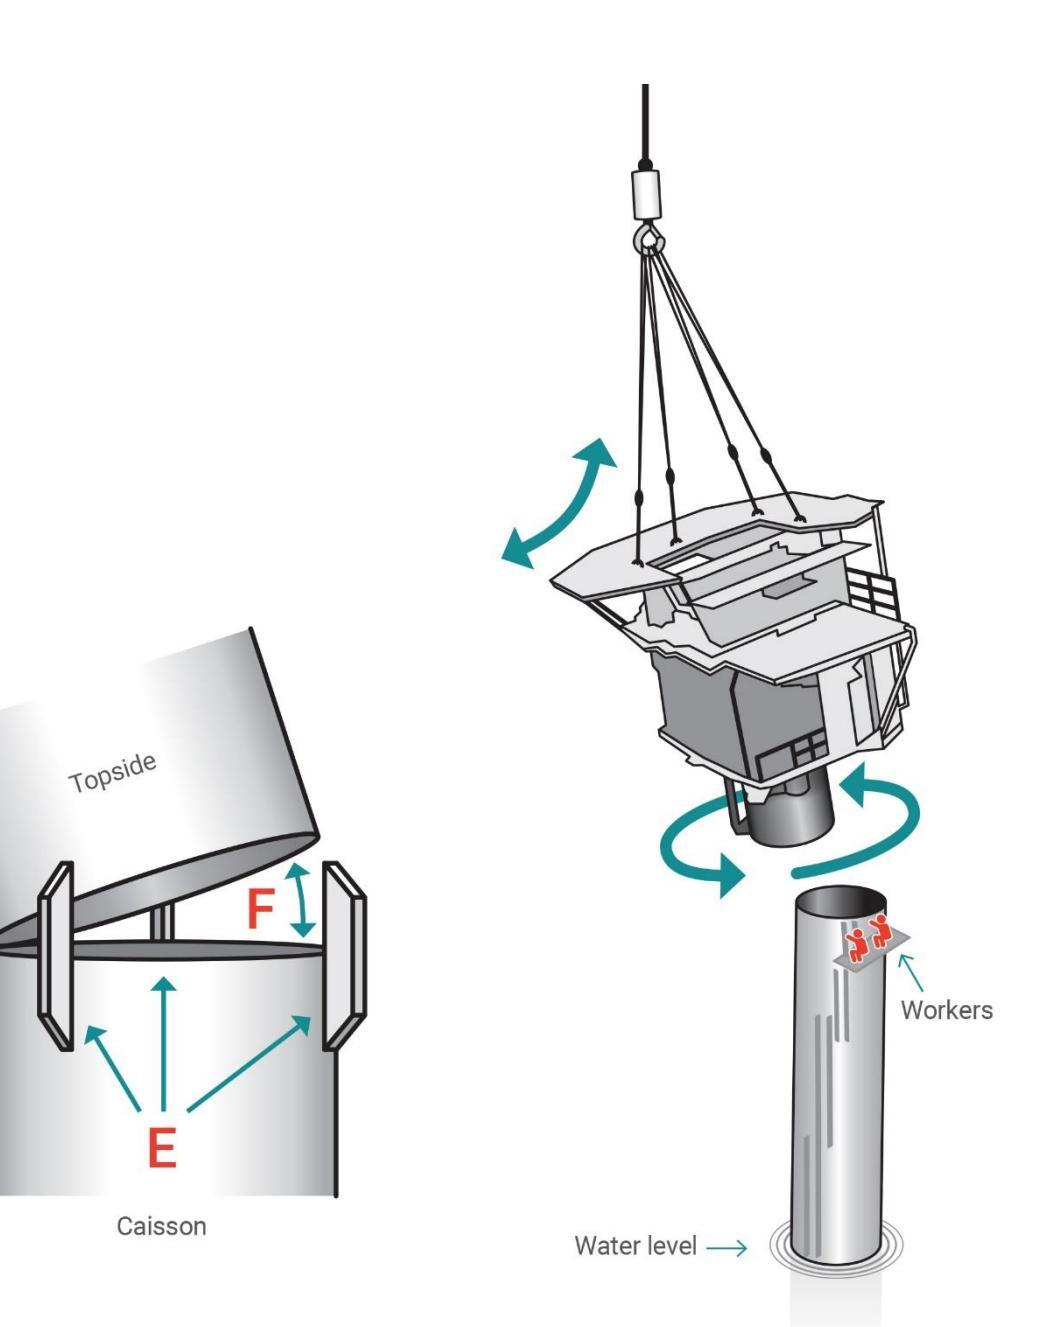
**Figure 3:** Temporary supports (**E**) on the caisson were insufficient to prevent lateral displacement and rotation of the topside when it was lifted at small angles (**F**).

**Figure 4:** The load detaches from the caisson and begins to swing and rotate. The crane operator takes action to raise the load and then stabilise it in the water.
