eNERGY

bulletin

Government of Western Australia
Department of Commerce
Energy Safety

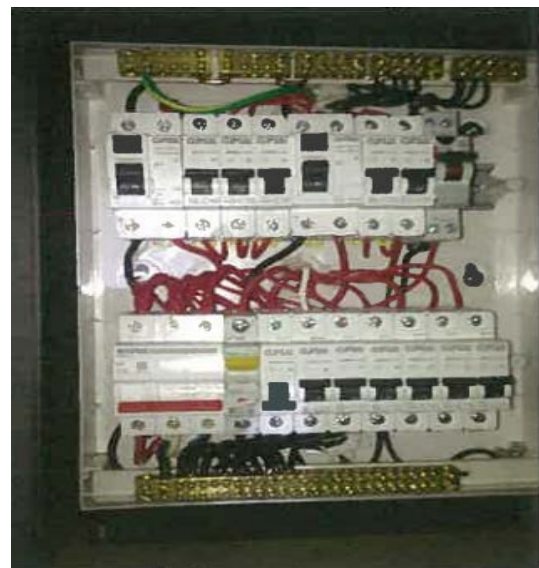
To make the installation safe, the network officer also installed an MEN link at the main neutral bar in the main switchboard and also issued an Inspector's Order for an electrical contractor to check and test the installation. The omission of the MEN link is a very serious defect.

The main switchboard with no MEN connection

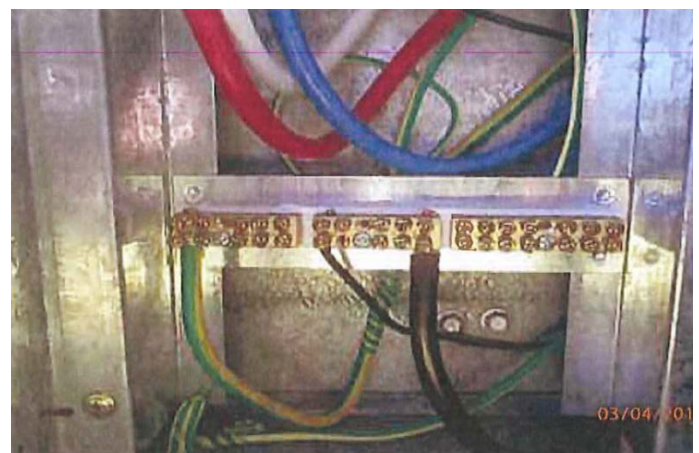
Main switchboard with no MEN connection

The electrical contractor's comprehension of the earthing arrangements was found to be inadequate. He held the mistaken belief that if a MEN link is installed on the main switchboard, a second MEN or running earth conductor is not required for the distribution board.

After issuing an Inspector's Order for the MEN omission and several other minor defects, the Inspector made the installation safe by isolating the electricity supply to the distribution board, fitting an "Out of Service" tag to the circuit breaker at the main switchboard and installing a temporary MEN link at the sub-board. An Inspector's Order was also issued for an electrical contractor to carry out the checking and testing of the main switchboard before the "Out of Service" tag could be removed.

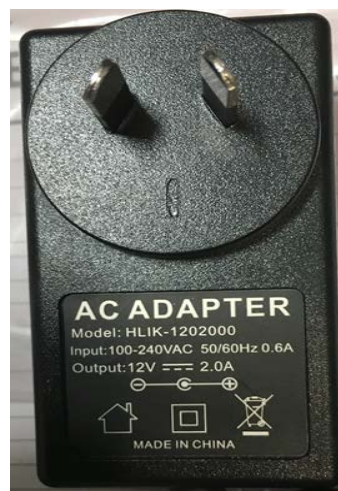
A therapeutic massage pillow for use on car seats was found to be on sale with an unapproved (prescribed) charger/power supply. The appliance had been imported from China.

Non-approved charger/power supply

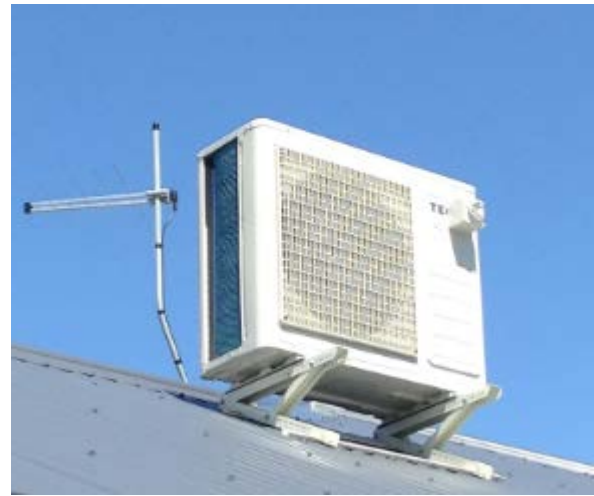
This creates an unsafe and dangerous situation for restricted electrical licence holders who require the removal of the

panel (the isolator is mounted on) to isolate the electricity supply. There is a risk of receiving an electric shock as the incoming electricity supply to the isolator is live.

Incorrectly mounted isolator switch fitted to the panel of the external airconditioning unit

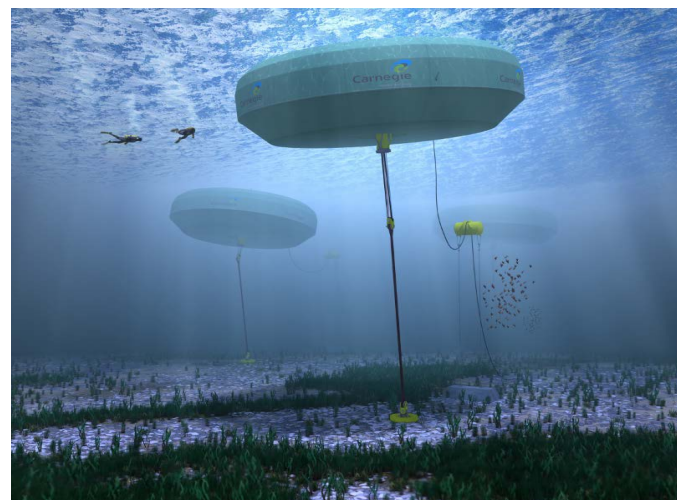
Carnegie's Garden Island Microgrid Project (GIMG) will be the world's first wave integrated microgrid system combining wave, solar PV, battery storage and desalination. The Project will be located onshore at Garden Island and connected to the off shore CETO 6 Project.

CETO 6 array

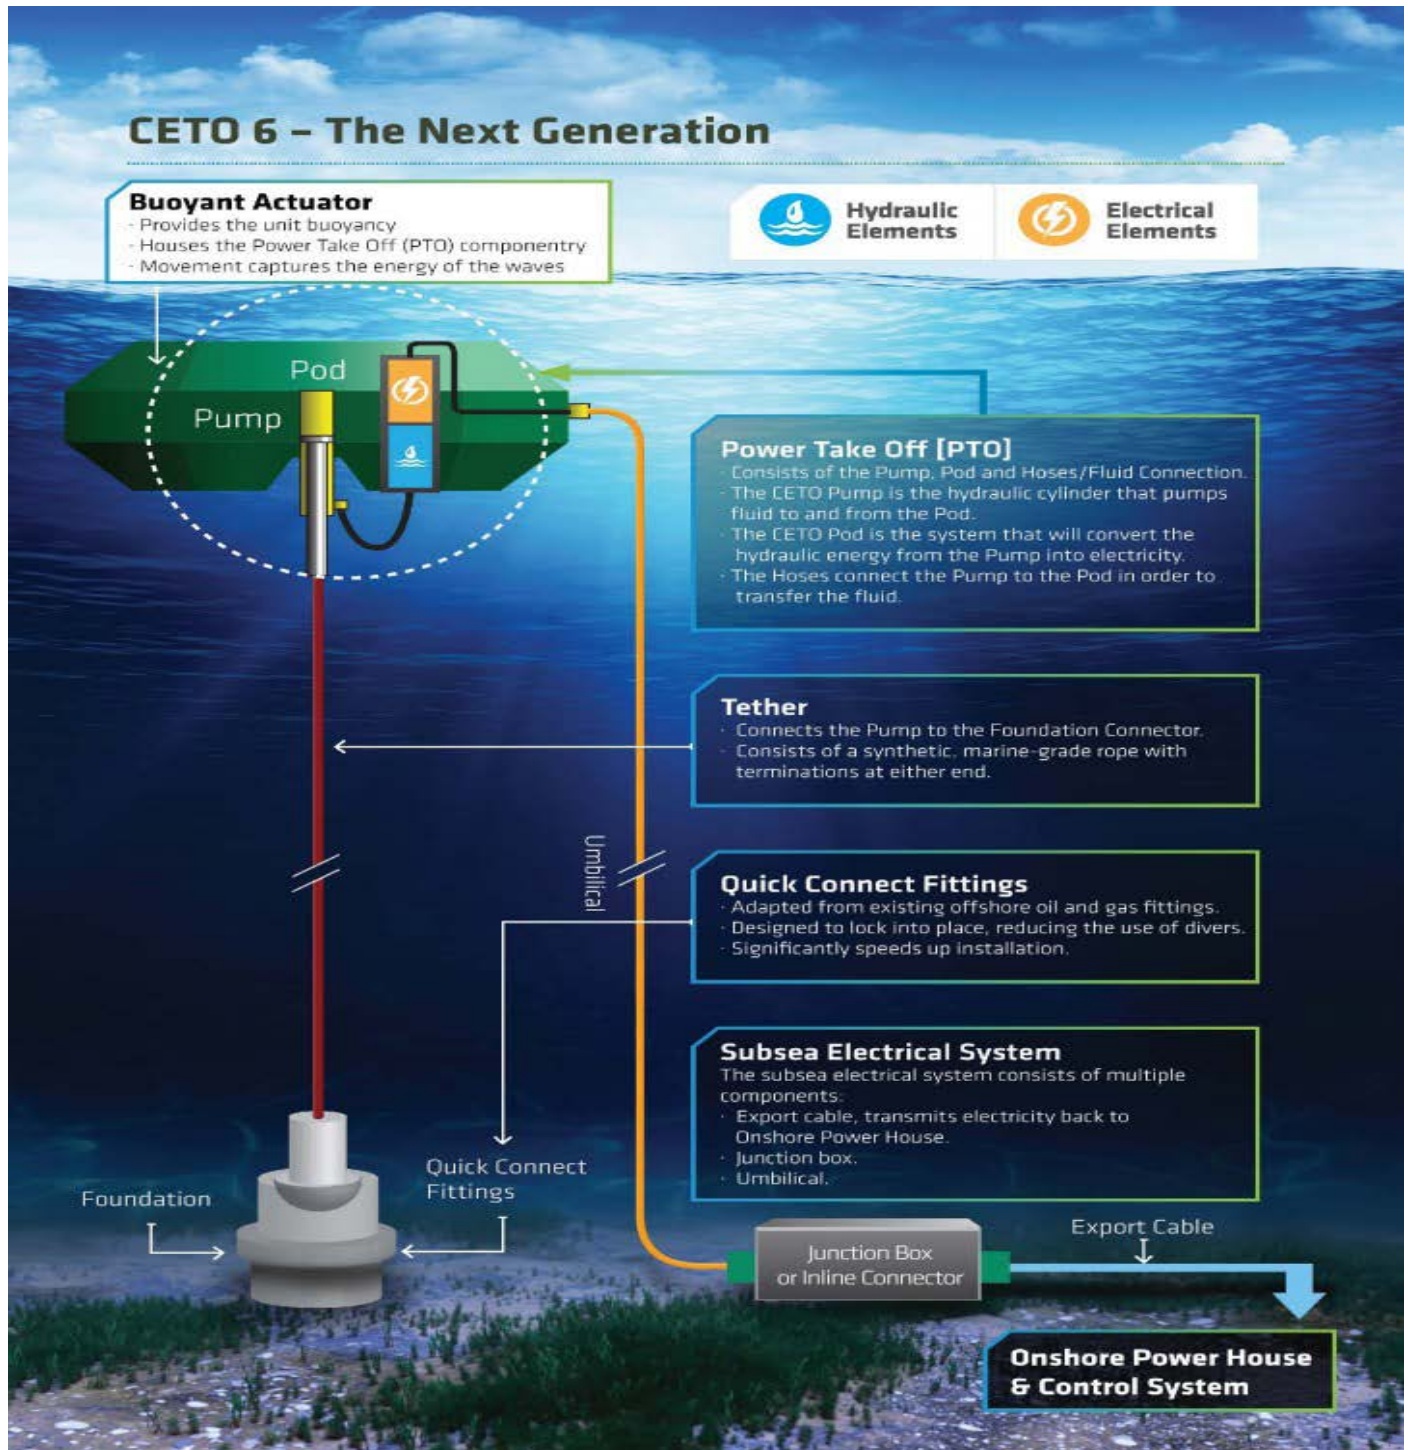
CETO 6 schematic

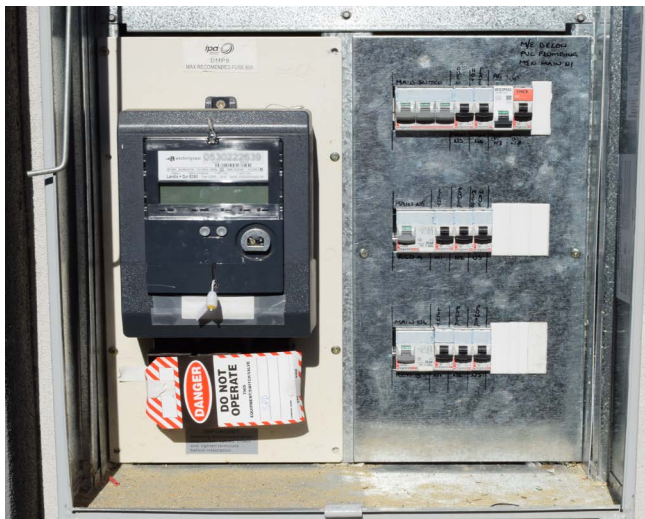
If the supply-side live terminal of the fuse base can be accessed, electricians need to insert a blank fuse carrier bearing a 'Danger' tag, especially if their task is likely to take some time.

Danger tag placed on the SPD

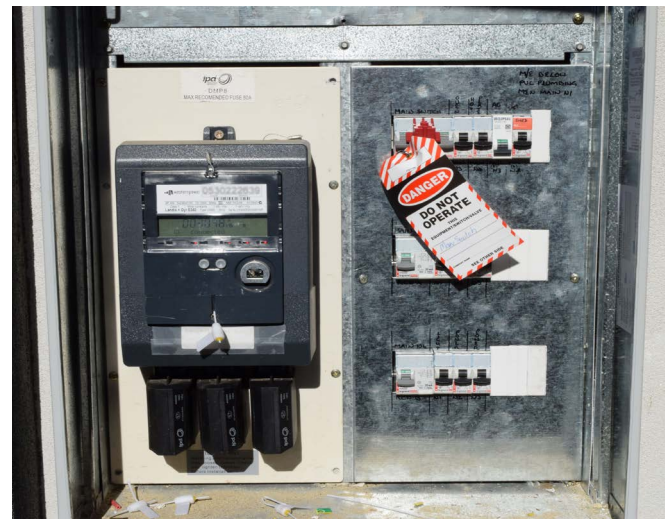
Electricians should retain custody of the SPD fuse carrier while carrying out their work. It should not be simply left in the switchboard enclosure, where another person could re-insert it.

Danger tag on the main switch

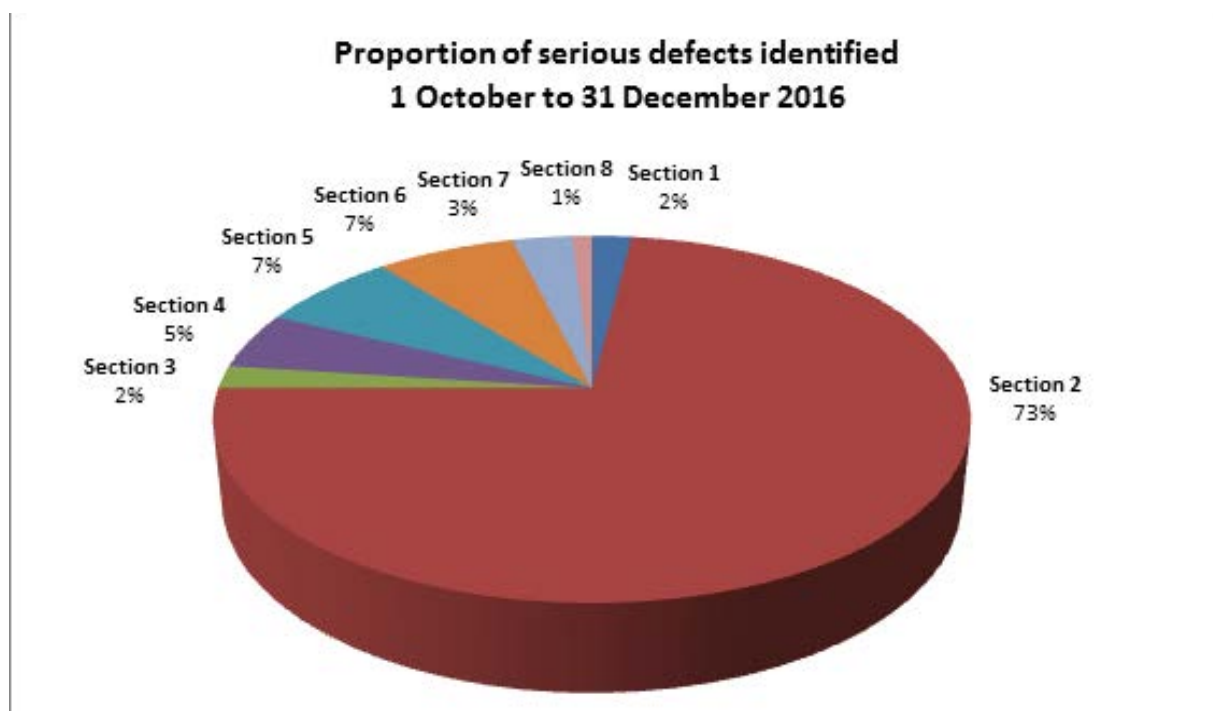
- Number of non-serious defects = 1,421
 - Number of serious defects = 291 (17%)
- TOTAL = 1,713

Pie chart showing the proportion of serious defects from Sections 1 to 8 of AS/NZS 3000: 2007, Wiring Rules

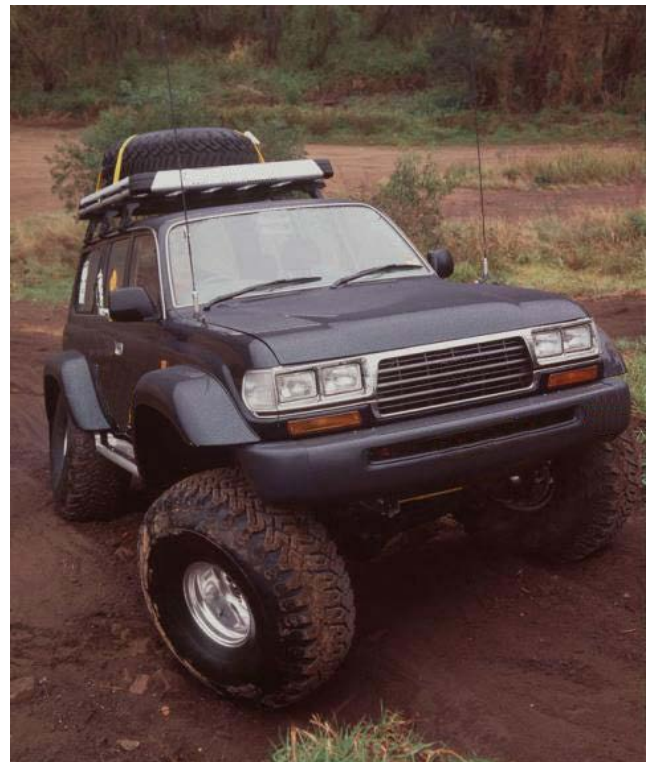
Inspections have revealed that in some circumstances rigid service lines have fractured although the installation methods are compliant. This phenomenon would be more prevalent on four wheel drive and all terrain vehicles that are being subjected to extended use on corrugated/rough roads and/or extreme terrain.

The autogas installation needs to be designed to accommodate the stresses associated with extreme body to chassis movement

EnergySafety encourages gas fitters to be mindful of the potential for work hardening of rigid metal piping on all vehicles with special attention to four wheel drive and all terrain vehicles. It should be remembered that the Standard requirements are a minimum and such situations should be considered prior to Installation.

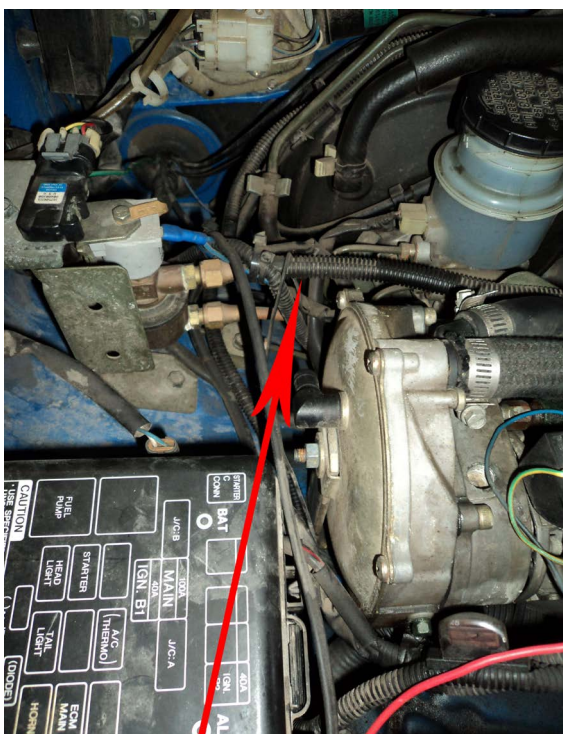
An example of such fracture is between the vaporiser/regulator and the engine bay automatic fuel shut off device (AFSOD). In this case the installation was on a four wheel drive which had been used extensively on rough terrain. The vaporiser/regulator was mounted on a substantial metal bracket, attached to the engine bay wall, and the AFSOD was securely mounted to the engine bay wall. The bracket was fixed at the bottom end only which allowed some minor flexibility. Under rough road surface conditions this was enough to work harden and fracture the copper piping. This problem has been alleviated by the replacement of the copper piping with suitable flexible piping. Fixing the vaporiser/regulator bracket at both ends would also alleviate such independent movement.

Area of fracture

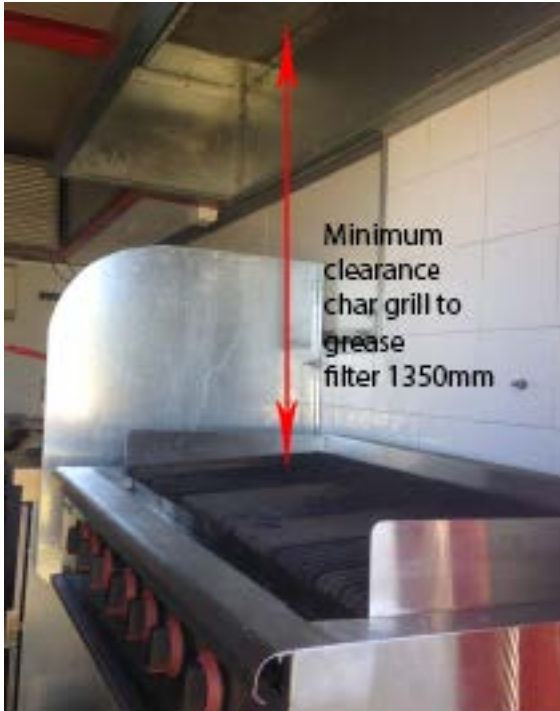
Gas appliance	Minimum clearance, mm
Kabab cooker/vertical grill	200
Solid grill plate, deep fryer (top of pan)	600
Open flame gas appliance (i.e. hotplate burner)	1050
Target top Chinese cooking table, griddle barbecue, char griller /broiler or open top flare griller/broiler	1350

Where multiple appliances are serviced by one extraction system, the distance from the cooking surface of each gas appliance to the grease filter shall be such that the minimum clearance in this table is applied to each respective appliance.

Minimum clearance for char grill to grease filter

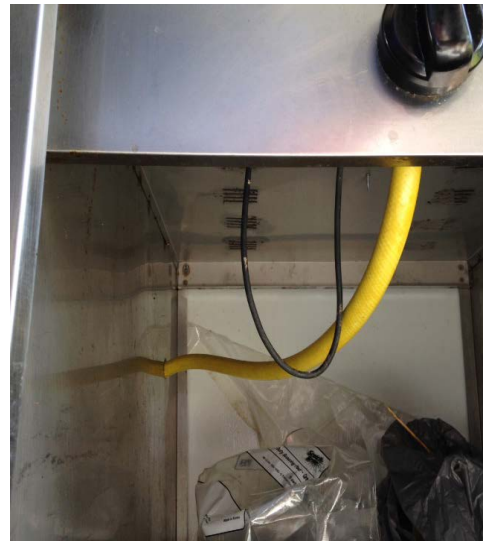
Copper consumer gas piping rising from under the trailer to the interior, had no grommet. Changing to a flexible gas hose which was secured with a hose clamp. The hose then passed through another hole in a stainless steel partition having sharp edges.

Hose passing through a stainless steel partition

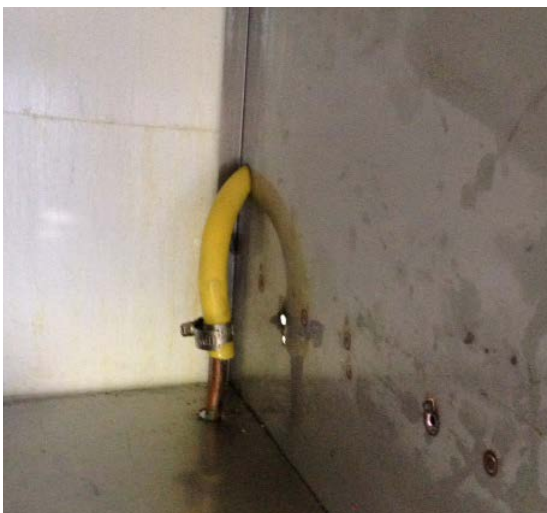
Flexible pipe secured with a hose clamp

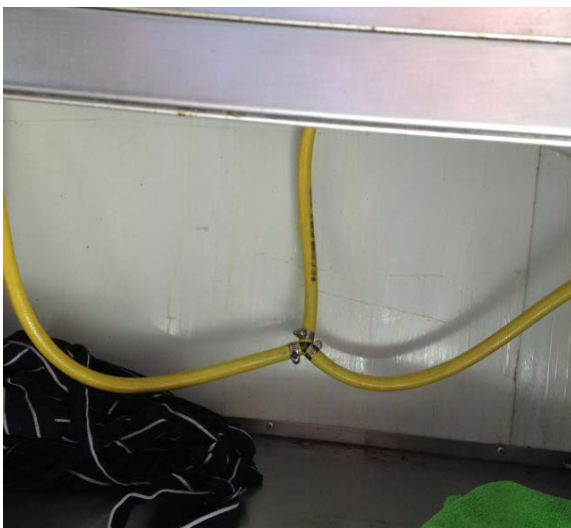
This hose passed through another hole in a partition. Hoses were used for the final connection to the gas appliances and in one case exposed to elevated temperatures of nearby burners. In repairing these non-compliances a second gas fitter reported the hose clamped joints just fell apart as he touched them.

Gas hoses secured with hose clamps
