electrical focus

Energy Safety

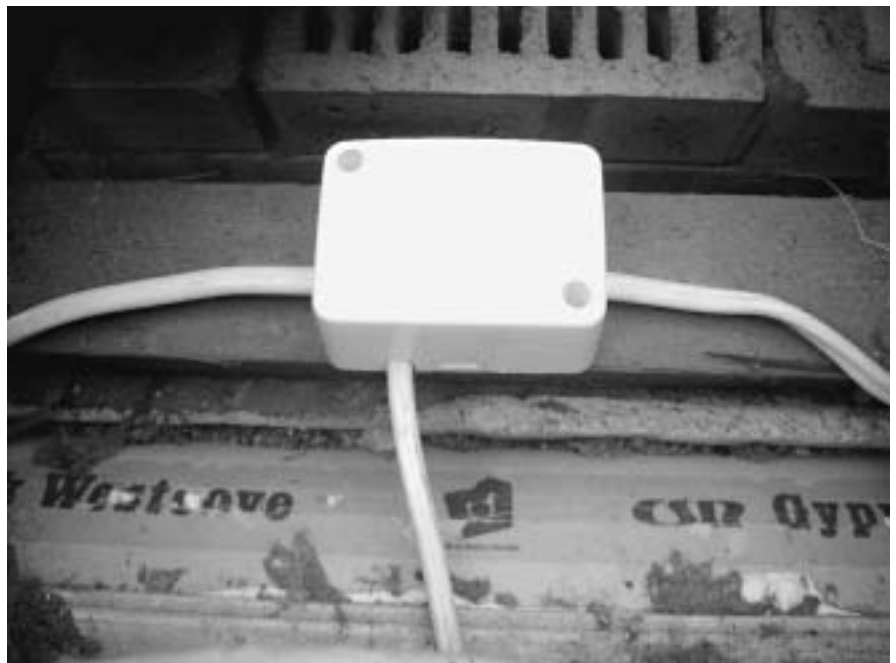
unenclosed joints in insulated cables constitute a defect and must be corrected.

If, during the course of their work, electrical contractors / electricians become aware of unenclosed joints in insulated cables, then in line with Regulation 62 of the *Electricity (Licensing) Regulations 1991*, they are required to report the matter to the owner/occupier of the installation. The defects should then be corrected.

If the owner/occupier of the installation will not authorise these defects to be corrected, electrical contractors must then report the matter to the relevant network operator (or Energy Safety if the network operator cannot be identified).
